# **Desert Research and Technology Studies exposure of Lotus coated electrodynamic shield samples – Part II**

The passive Lotus dust mitigation coating currently being developed at NASA's Goddard Space Flight Center (GSFC), was selected by the Habitation Demonstration Unit Deep Space Habitat (HDU-DSH) for participation in the 2011 Desert Research and Technology Studies (D-RaTS). Based on the unique surface architecture of the Lotus leaf, the nano-engineered Lotus coating seeks to replicate these structures on space flight and habitation surfaces. By decreasing both the surface energy and area for particle attachment, the Lotus coating greatly diminishes dust accumulation on surfaces. This is a problem that can be encountered on lunar, Martian, and asteroid missions. Two different application methods of this coating were tested in summer 2011 at the D-RaTS site: the wet chemistry applied version and combustion chemical vapor deposition (CCVD) applied version. These Lotus coatings, along with two common thermal control coatings, were combined with the active dust mitigation electrodynamic shield (EDS) technology developed at Kennedy Space Center (KSC). The EDS technology uses an ele

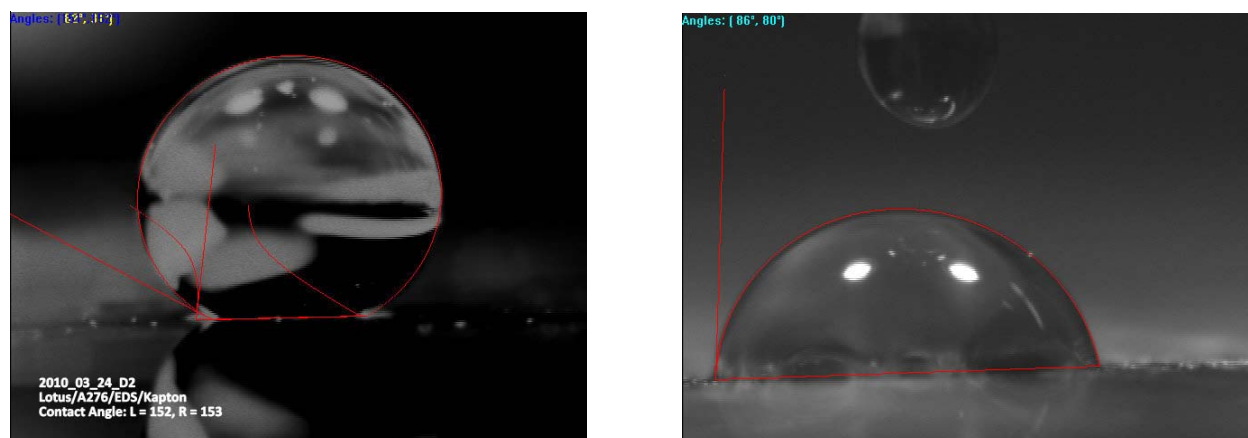
Figure 3: 2010\_03\_24\_D2 Contact Angle - Left: Pre-D-RaTS Exposure - Contact Angle =  $153^\circ$ ; Right: Post-D-RaTS Exposure - Contact Angle =  $83^\circ$  ( $96^\circ$  average)

Table 2 below displays the contact angle measurements of the samples pre-Lotus coating, post-Lotus coating and post D-RaTS as well as the overall change in contact angle from post-Lotus coating to post exposure. The figures below are goniometer captured contact angle measurements from several of the D-RaTS exposed samples, pre and post exposure.

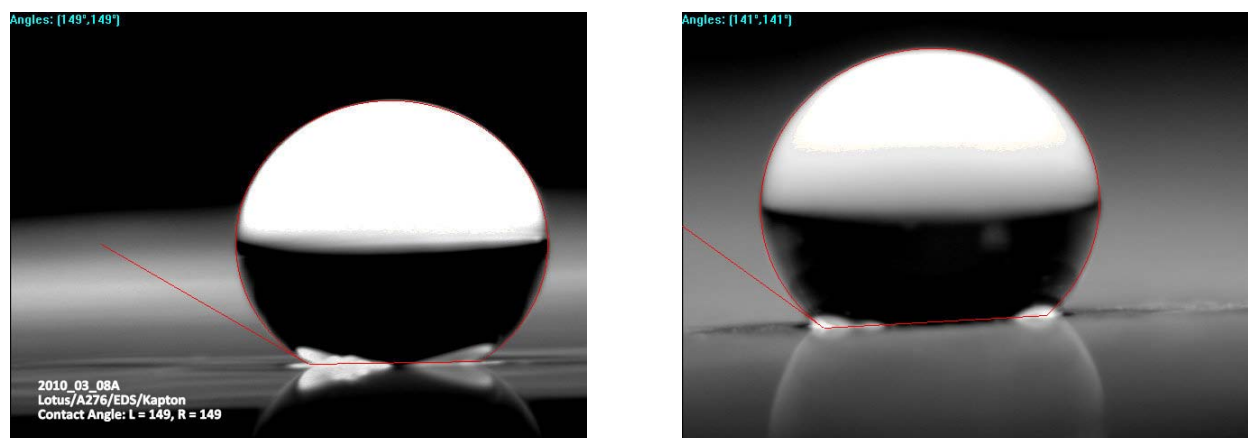
Figure 4: 2010\_03\_08A Contact Angle - Left: Pre-D-RaTS Exposure - Contact Angle =  $149^\circ$ ; Right: Post-D-RaTS Exposure - Contact Angle =  $141^\circ$  ( $130^\circ$  average)

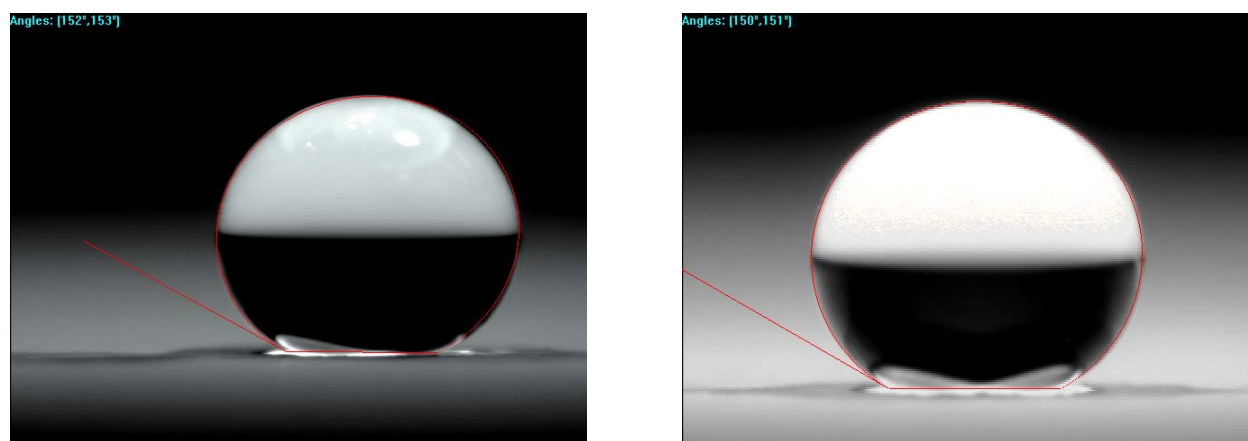
Figure 5: F1T8033011 Contact Angle - Left: Pre-D-RaTS Exposure - Contact Angle =  $153^\circ$ ; Right: Post-D-RaTS Exposure - Contact Angle =  $151^\circ$  ( $151^\circ$  average)

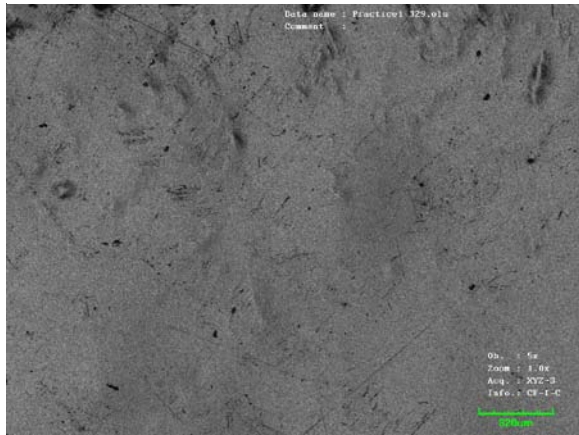
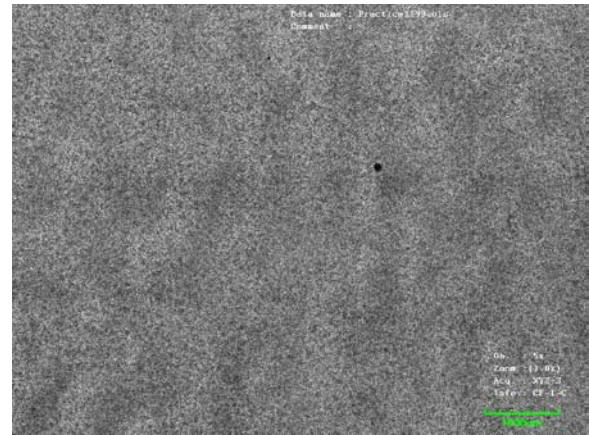
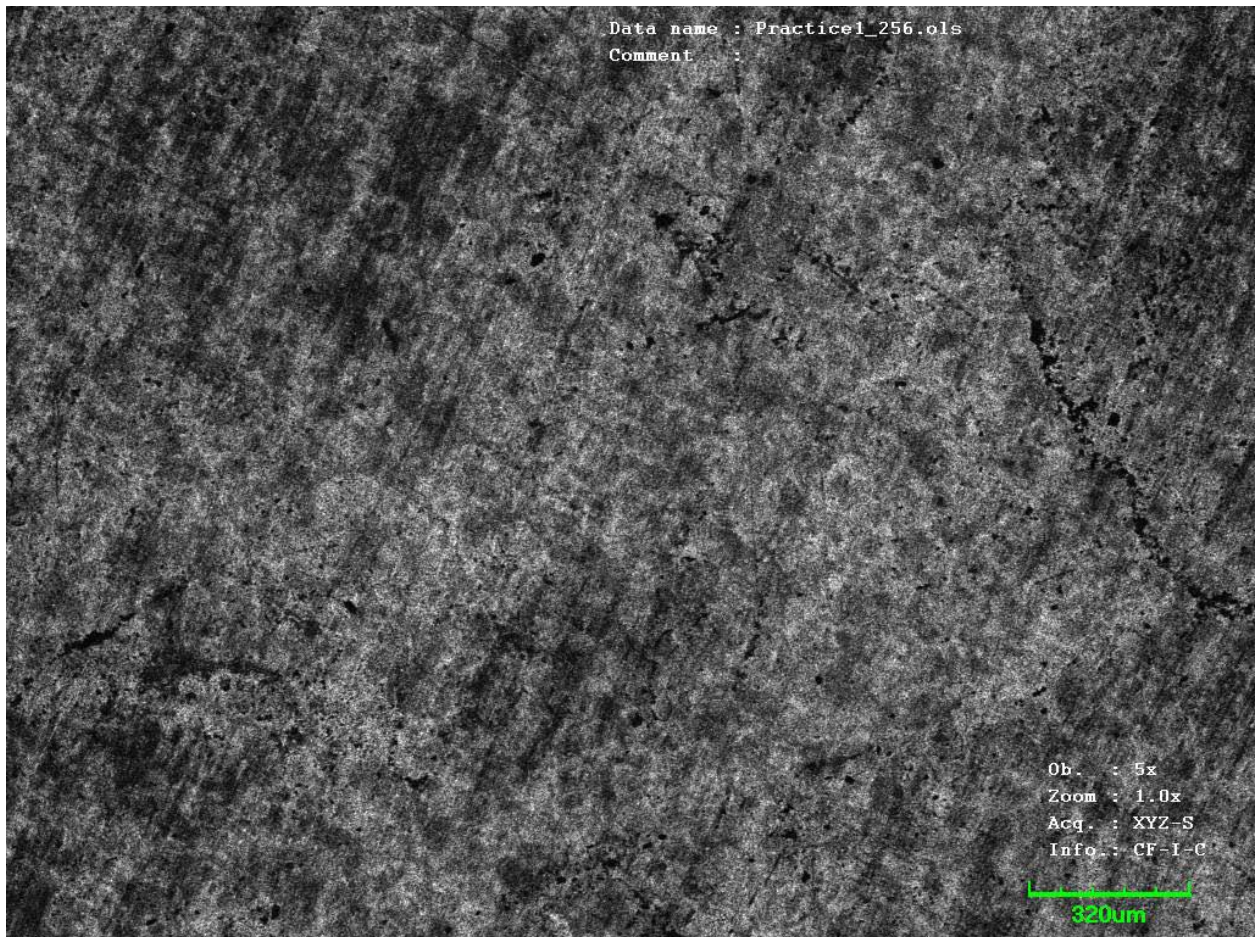
Figure 6: Left: A276 Representative Sample – No Lotus Coating - Unexposed - 2D 5X; Right: 2010\_03\_08A with Lotus Coating – Unexposed – 2D 5X; Bottom 2010\_03\_08A – D-RaTS Exposed – 2D 5X

Prior to Lotus coating application, A276 coated substrates are slightly rougher than just Kapton™ substrates with an average surface roughness of 4.5 microns. After the CCVD application of the Lotus coating, the average surface roughness of these samples increased to 8.2 microns. After D-RaTS exposure of these samples, the average surface roughness decreased slightly by an average of 1 micron. This is a very slight decrease compared to the decrease of demonstrated by the plain Kapton™ samples. This can be attributed to the already textured surface of A276 to which the Lotus coating was applied to. The texture of the A276 allowed the Lotus coating to deposit in existing valleys thus shielding it from some detrimental environmental or handling damage. Since the CCVD method uses a flame spray to apply the Lotus coating, coating is also applied to the existing peaks on the surface of the samples as well. This coating on the peaks is especially vulnerable to handling and environmental exposure damage. It is this peak coating removal that might be responsible for the decrease in contact angle of these samples from the superhydrophobic threshold to the hydrophobic threshold.

Table 3 below displays the surface roughness measurements of the samples pre-Lotus coating, post-Lotus coating and post D-RaTS exposure as well as the overall change in surface roughness from post-Lotus coating to post exposure. The figures below are 2-dimensional, 5X objective confocal images captured of the samples or representative samples in all of the above listed time frames.

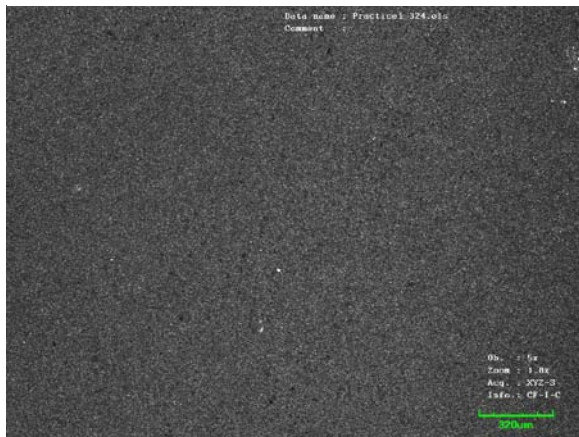
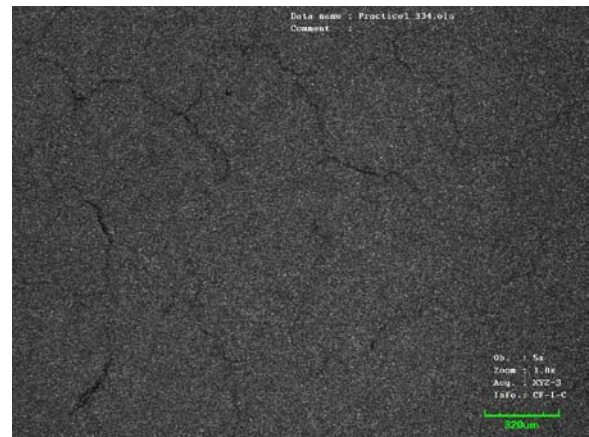
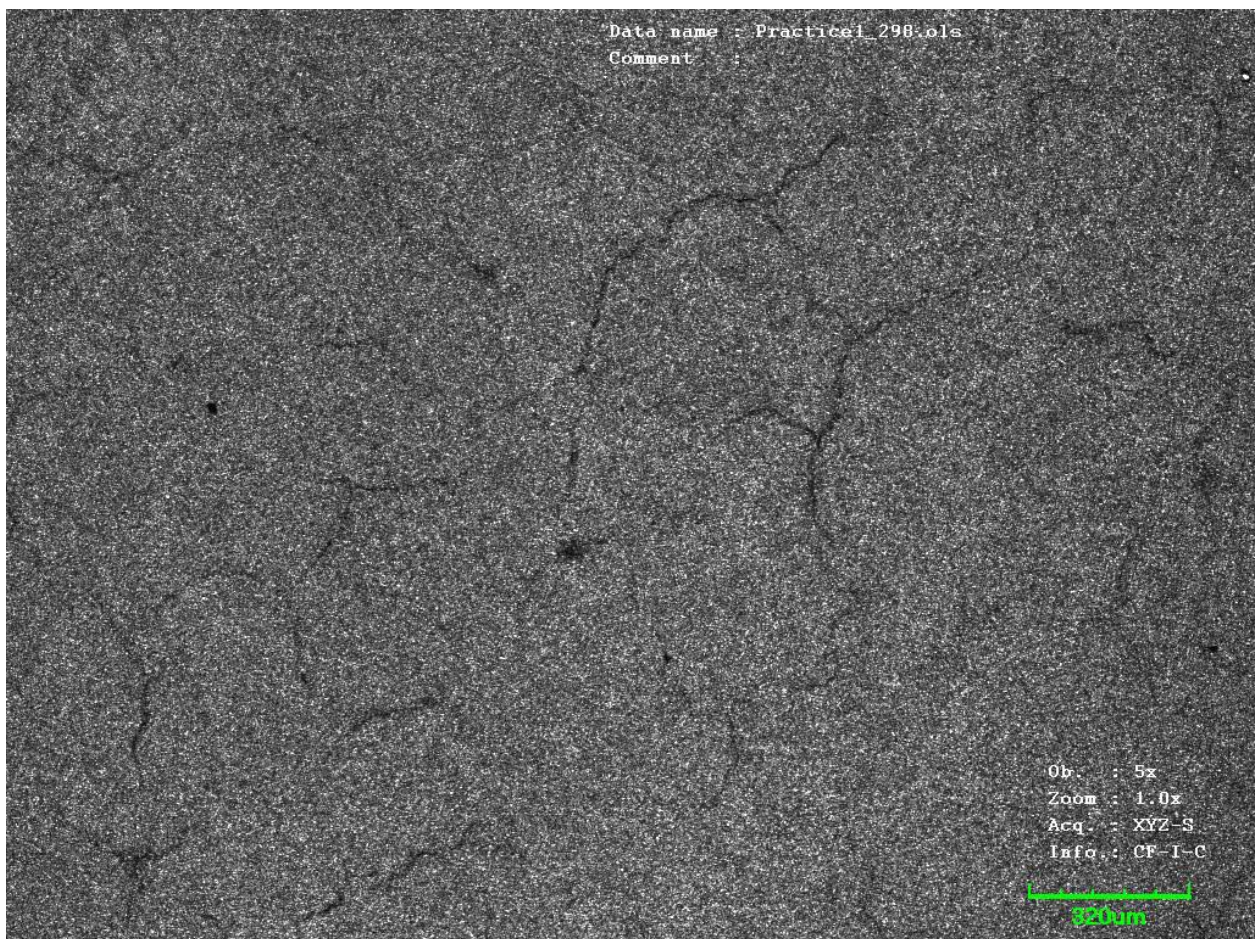
Figure 7: Left: Z93/Al Representative Sample - No Lotus Coating - 2D 5X; Right: Z93/Al with Lotus Representative Sample - 2D 5X; Bottom: F1T5033011 D-RaTS Exposed - 2D 5X

Prior to Lotus coating application, Z93 coated substrates are also slightly rougher than just Kapton™ substrates with an average surface roughness of 4.0 microns. After the wet chemistry application of the Lotus coating, the average surface roughness of these samples decreased negligibly by 0.3 microns. Due to the silicate nature of Z93 which is very porous, the Lotus coating was allowed to deposit in existing valleys on the surface. This is similar to the effect seen by the A276 coated samples however unlike the flame spray CCVD method, the wet chemistry method uses a spin coater to apply the Lotus coating. This insures that the coating is mostly deposited in the existing valleys of the surface of the sample thus limiting peak coating removal which has been shown to be detrimental to the A276 coated samples. After D-RaTS exposure of these samples, the average surface roughness also increased negligibly by 0.3 microns. Thus the contact angle for these samples changed the least out of all of the exposed samples, only an average of 2°.

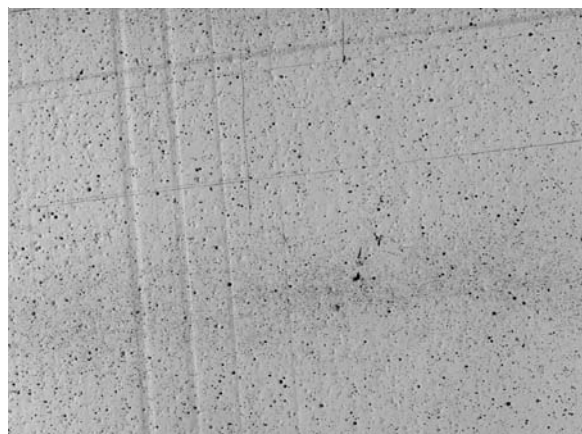
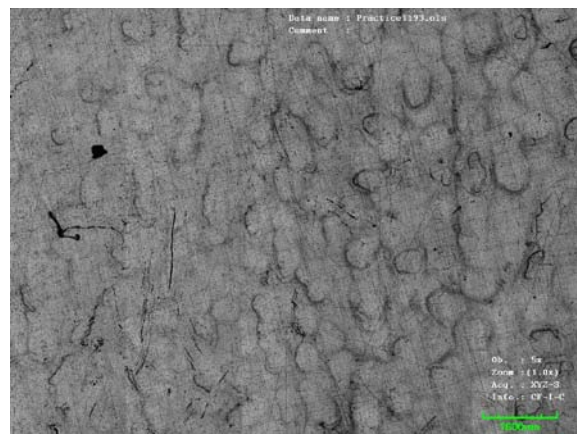
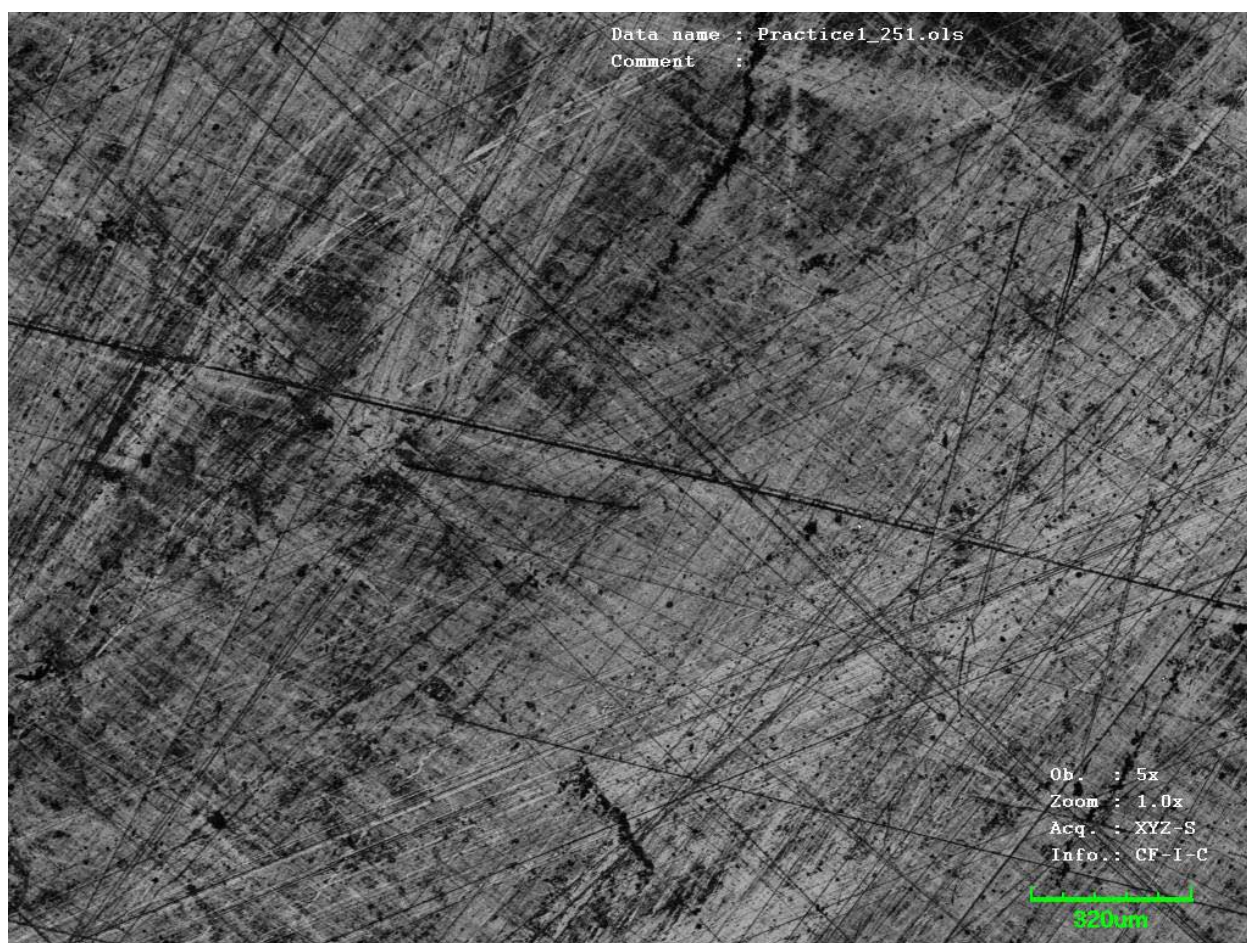
Figure 8: Left: EDS/Kapton(TM) Representative Sample - No Lotus Coating - 2D 5X; Right: 2010\_03\_24\_D2 with Lotus – Unexposed - 2D 5X; Bottom: 2010\_03\_24\_D2 – D-RaTS Exposed – 2D 5X

Prior to Lotus coating application, Kapton™ substrates are very smooth with an average surface roughness of 1.7 microns however after the CCVD application of the Lotus coating, the average surface roughness of these samples increased to 11.4 microns. This increase is responsible for the hydrophobic nature of the coating. After D-RaTS exposure of these samples, the average surface roughness decreased to an average of 8.0 microns. This decrease is responsible for the decrease in contact angle that these samples demonstrated post exposure. Control Kapton™ samples which were not exposed during D-RaTS showed a slight change in surface roughness as well however this could be attributed to differences in measurement locations and is negligible.

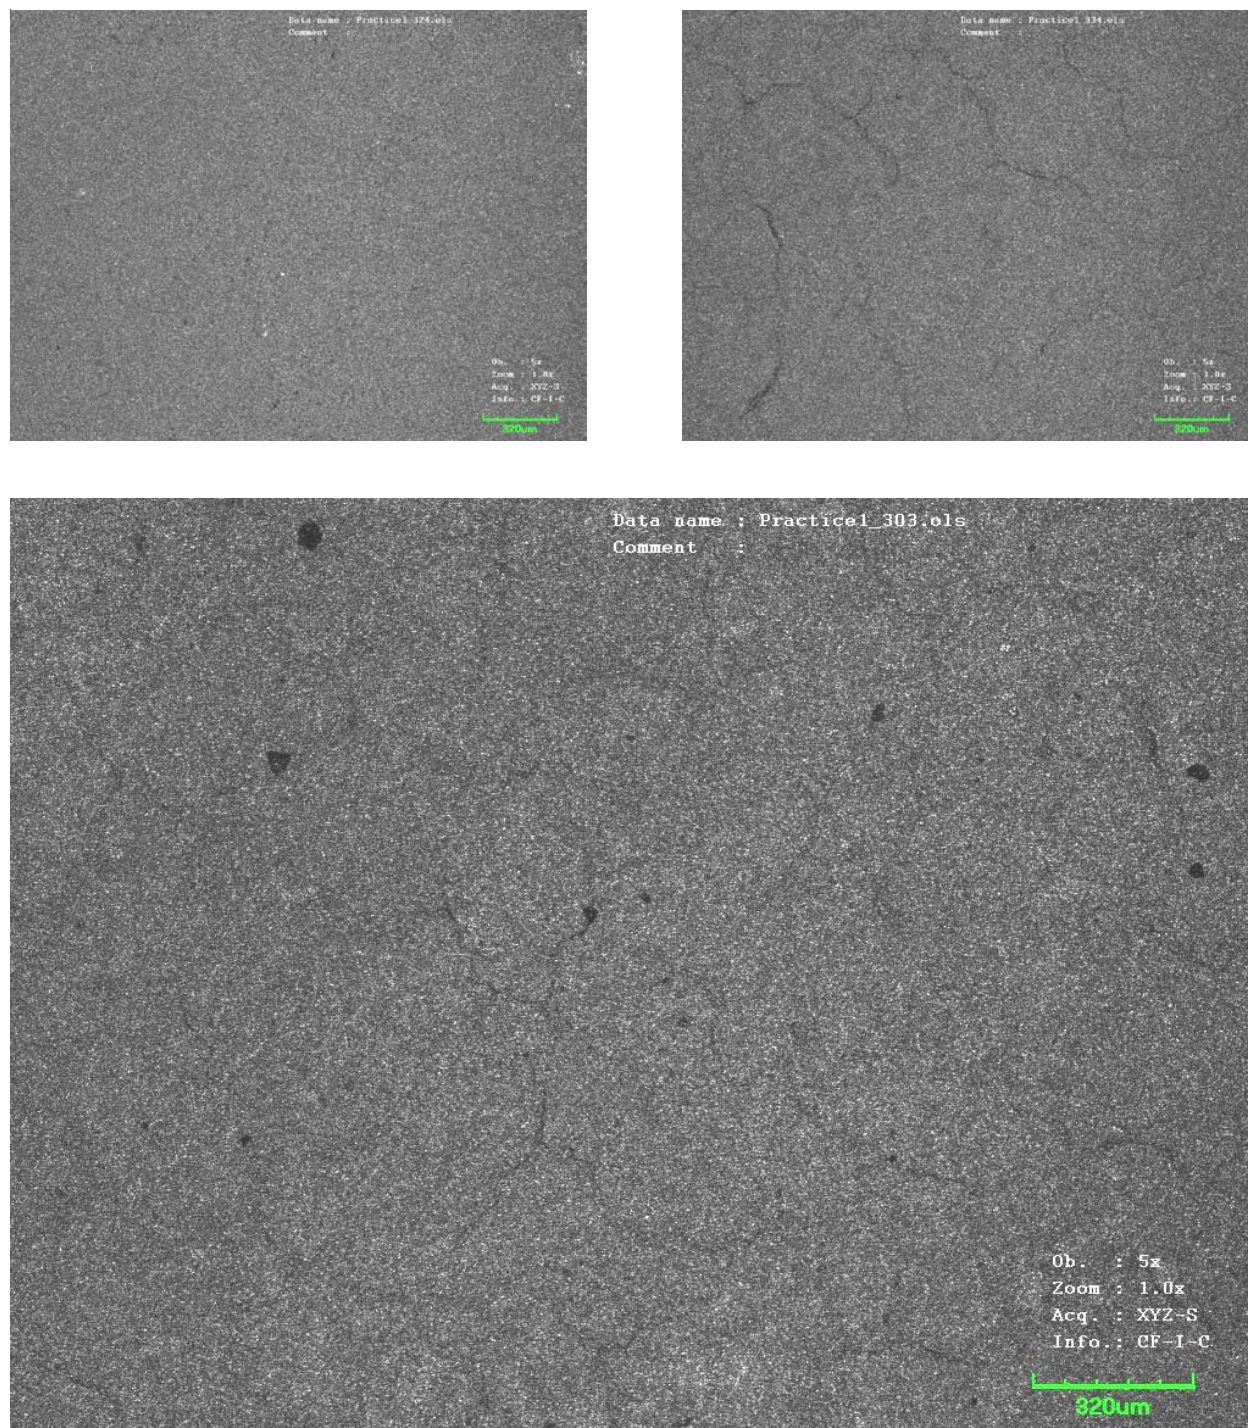
Figure 9: Left: AZ93/Al Representative Sample - No Lotus Coating - 2D 5X; Right: 033011 Representative Sample with Lotus – Unexposed - 2D 5X; Bottom: FIT8033011 – D-RaTS Exposed – 2D 5X

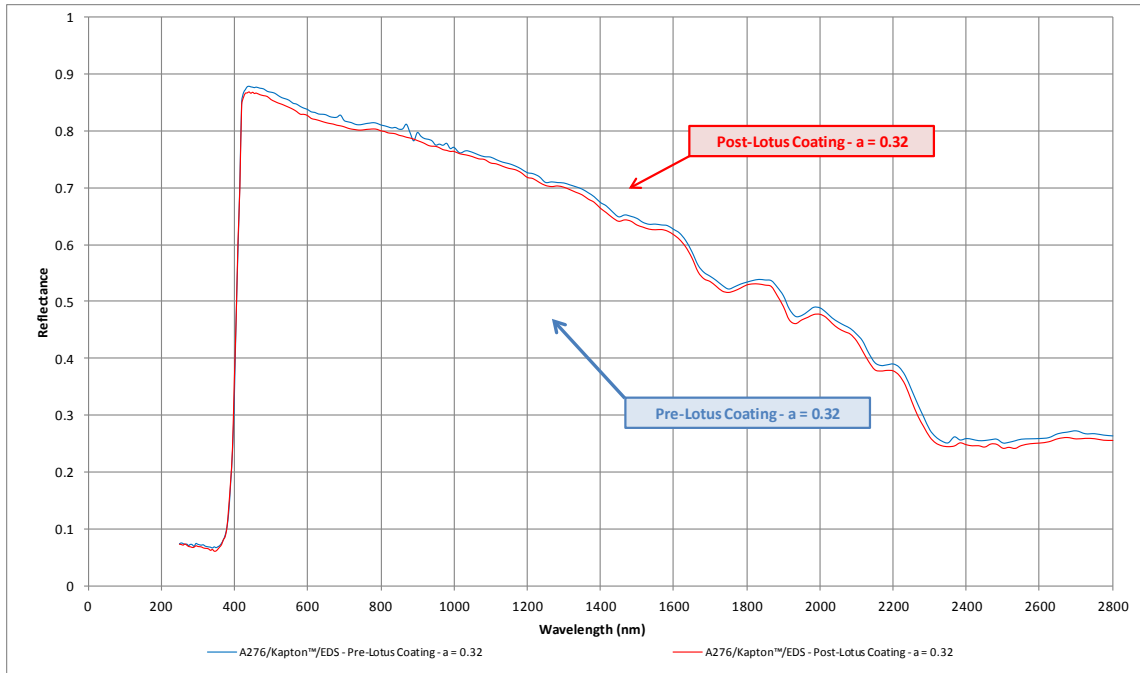
Chart 1: A276/EDS/Kapton™ - Pre- and Post-Lotus Coating Reflectance Graph

Solar absorptance measurements were taken on all samples prior to Lotus coating application and post Lotus coating application. The following charts show the difference in the reflectance curves from pre-Lotus coating to post-Lotus coating for the three different types of samples exposed at D-RaTS. When applied to existing thermal control

coatings, either Z93 or A276, the Lotus coating, both formulations are almost optically clear between 250 to 2800 nm. This can be seen in Charts 1 and 2.

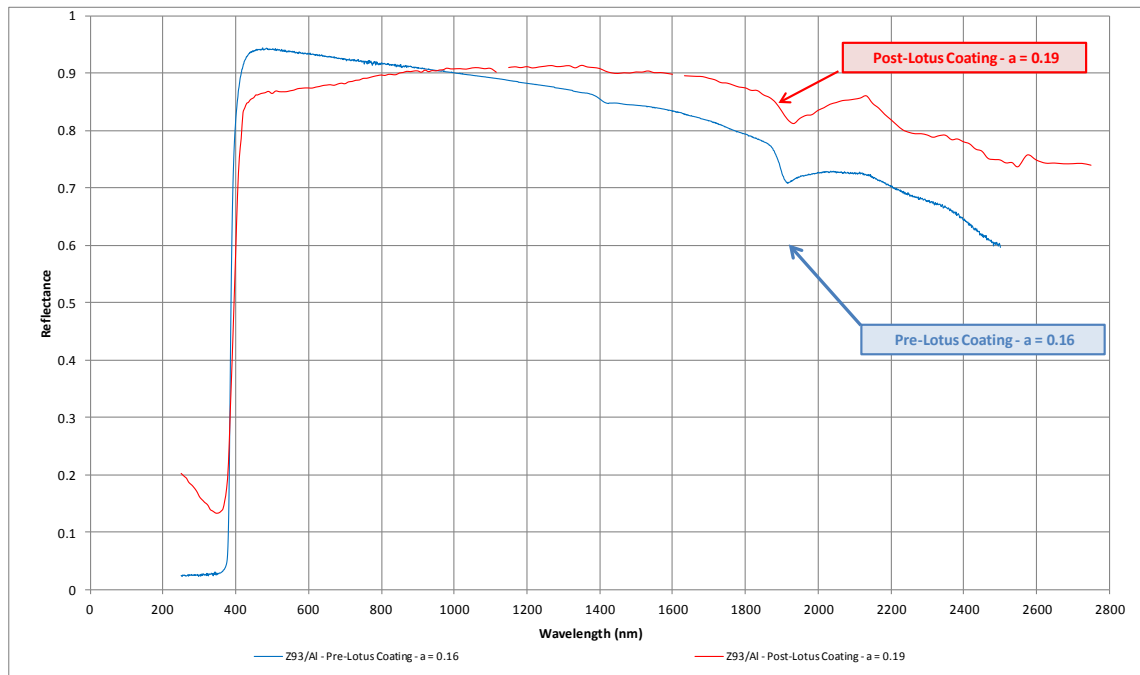
Chart 2: Z93/Aluminum - Pre- and Post-Lotus Coating Reflectance Graph

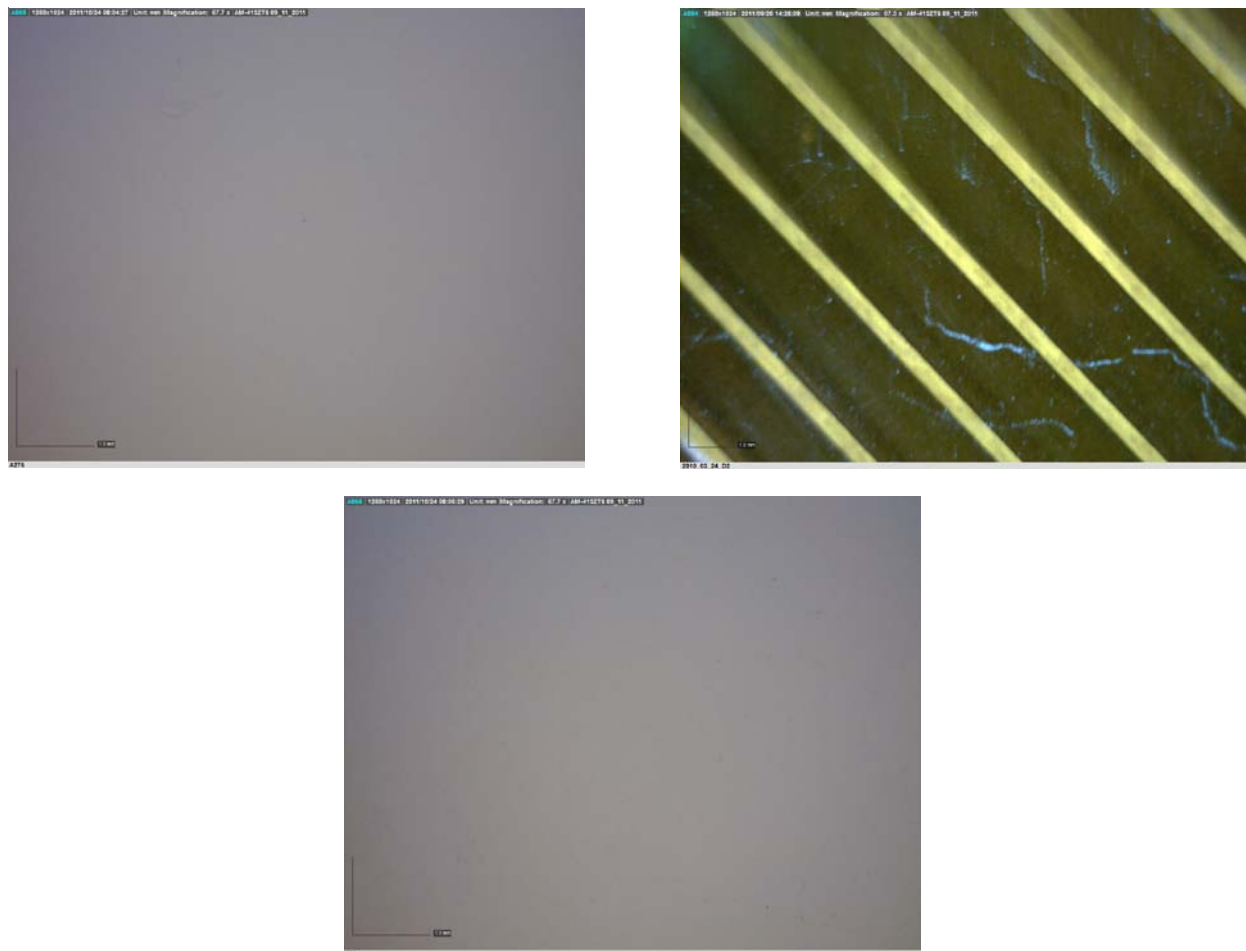
Dino-Lite microscopic images were taken on the samples prior to D-RaTS exposure, during exposure, and when the samples were returned to GSFC on September 20, 2011. Several different magnifications were used while taking in-situ and post-exposure measurements. Images in Figure 10 show the surface of samples prior to D-RaTS exposure. The white thermal control coatings appear very clean with very few dust or dirt particles present. The Kapton™ substrate sample in this image also appears to be clean and mostly free of dust particles.

Figure 10: Left: A276 Representative Dino-Lite Image 67X - Pre D-RaTS Exposure; Right: EDS/Kapton™ Representative Dino-Lite Image 67X – Pre D-RaTS Exposure; Bottom: Z93 Representative Dino-Lite Image 67X – Pre D-RaTS Exposure

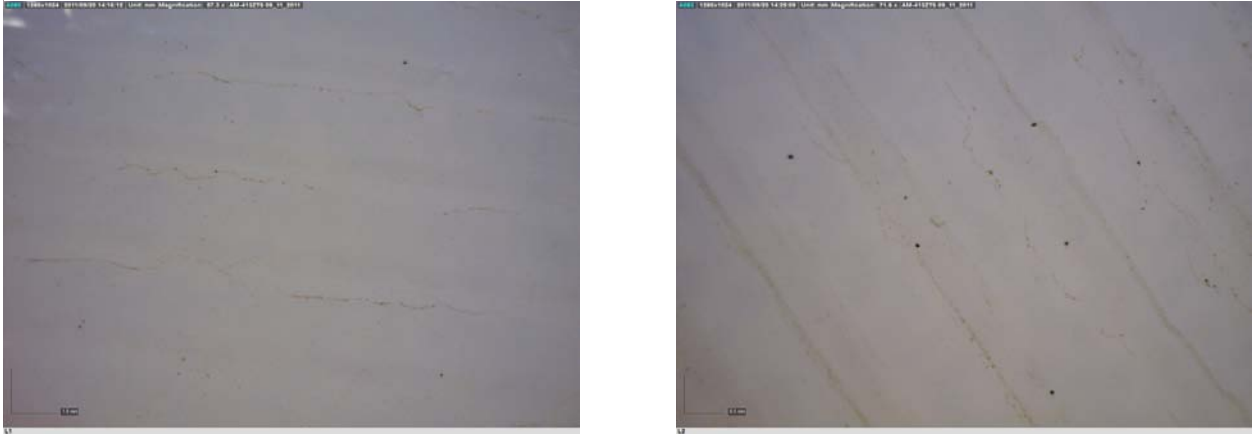
Figure 11 shows two post D-RaTS exposure images of an A276 coated Kapton™ EDS panel. Both images show contamination and streaking along the surface of the sample. Large dust particles appear scattered throughout the images and smaller dust particles appear in the streaks. Streaking on the Kapton™ EDS samples could have been caused by improper handling during exposure. A wet wipe was used to wipe the panels at one time. Prior to this, the panels were accumulating a large amount of caked-on dust. Dust became caked-on to the panels due to intermittent rain showers experienced at the D-RaTS site. The dust needed to be cleared in order to properly test the capabilities of the EDS. Unfortunately this caused streaking on the surface of the samples and led to small dust particles becoming trapped onto the surface. Despite this streaking, the EDS performed well on all of the panels after manual dust removal. This incident and its affects will be further discussed.

Figure 11: Left: L1 Dino-Lite Image 57X - Post D-RaTS Exposure; Right: L2 Dino-Lite Image 72X – Post D-RaTS Exposure

Several of the EDS samples were wiped once with a damp wipe during the exposure. The wipe was to remove well-adhered dust particles from the surface. Due to the unpredictable weather at the test site, the samples had been exposed to heavy rain, wind, and hail during their dust exposure. This was not planned or intended. Following this exposure there were several areas on the panels which had extremely well-adhered dust particles. A very light wipe was performed during this time to remove the particles. It was suspected that such a wipe would not harm the hydrophobic properties if performed lightly. According to the contact angle measurements performed before and after the exposure, the wiping only slightly affected the hydrophobic properties although it is impossible to tell which parameter, the wiping or the exposure, actually affected these measurements.

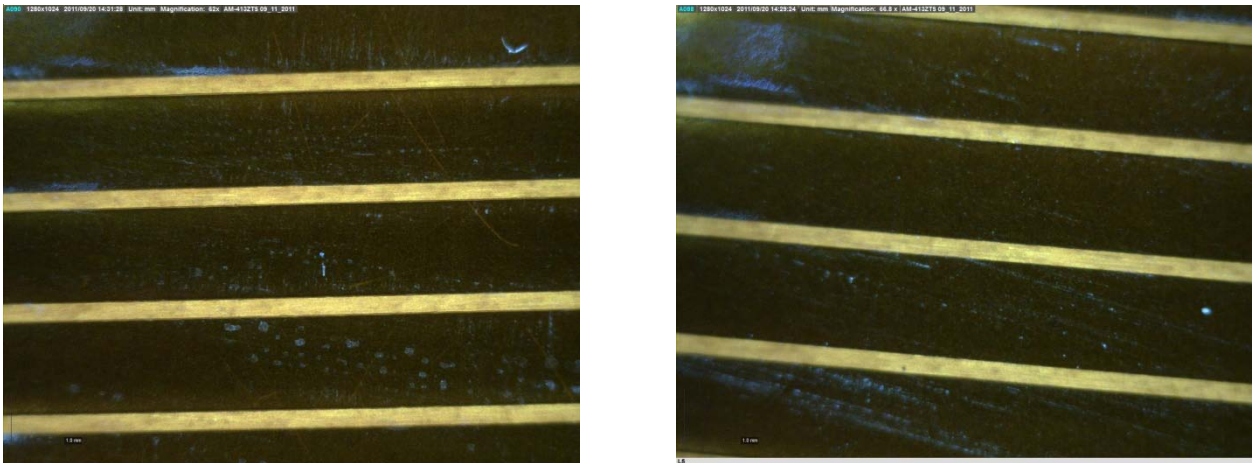
Figure 12 shows two post D-RaTS exposure images of Kapton™ EDS samples. Streaking can also be seen in these images. Dried water droplets appear in the magnified images on the surface of this sample however very few dust particles appear on these samples.

Figure 12: Left: L4 Dino-Lite Image 62X - Post D-RaTS Exposure; Right: L5 Dino-Lite Image 67X - Post D-RaTS Exposure

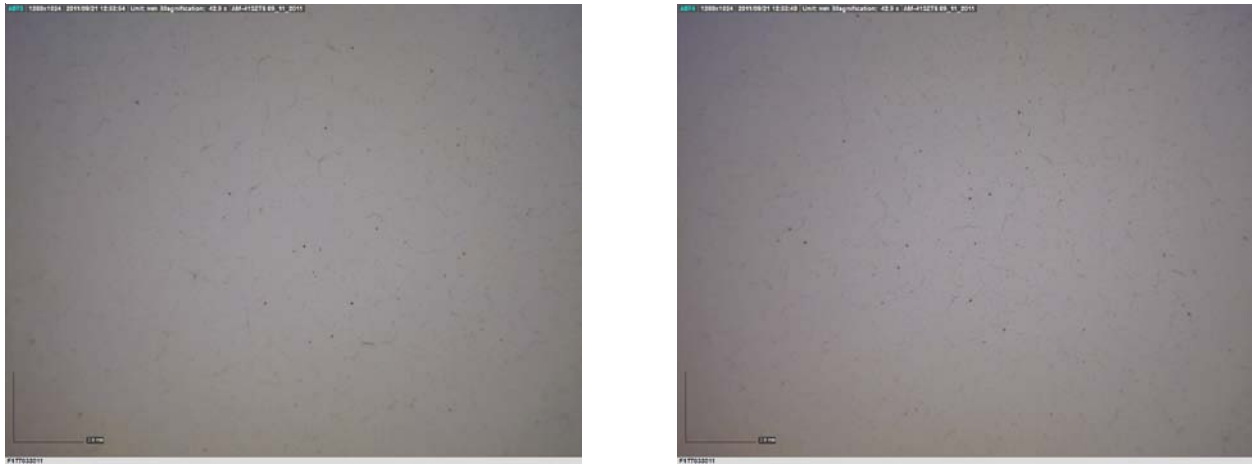
Figure 13 shows two post D-RaTS exposure images of Z93 samples. Due to the porous nature of the Z93, jagged dust particles are more apt to become stuck in the coating. Also, these samples did not have the EDS to help remove lodged dust particles and these samples were also not wiped during the exposure.

Figure 13: Left: F1T7033011 Dino-Lite Image 43X - Post D-RaTS exposure; Right: F1T7033011 Dino-Lite Image 43X – Post D-RaTS Exposure
